U-6A / NU-1B System

# U-6A / NU-1B Technical Support Contract

## Technical Assistance Activity Accomplishment Report

June 2002

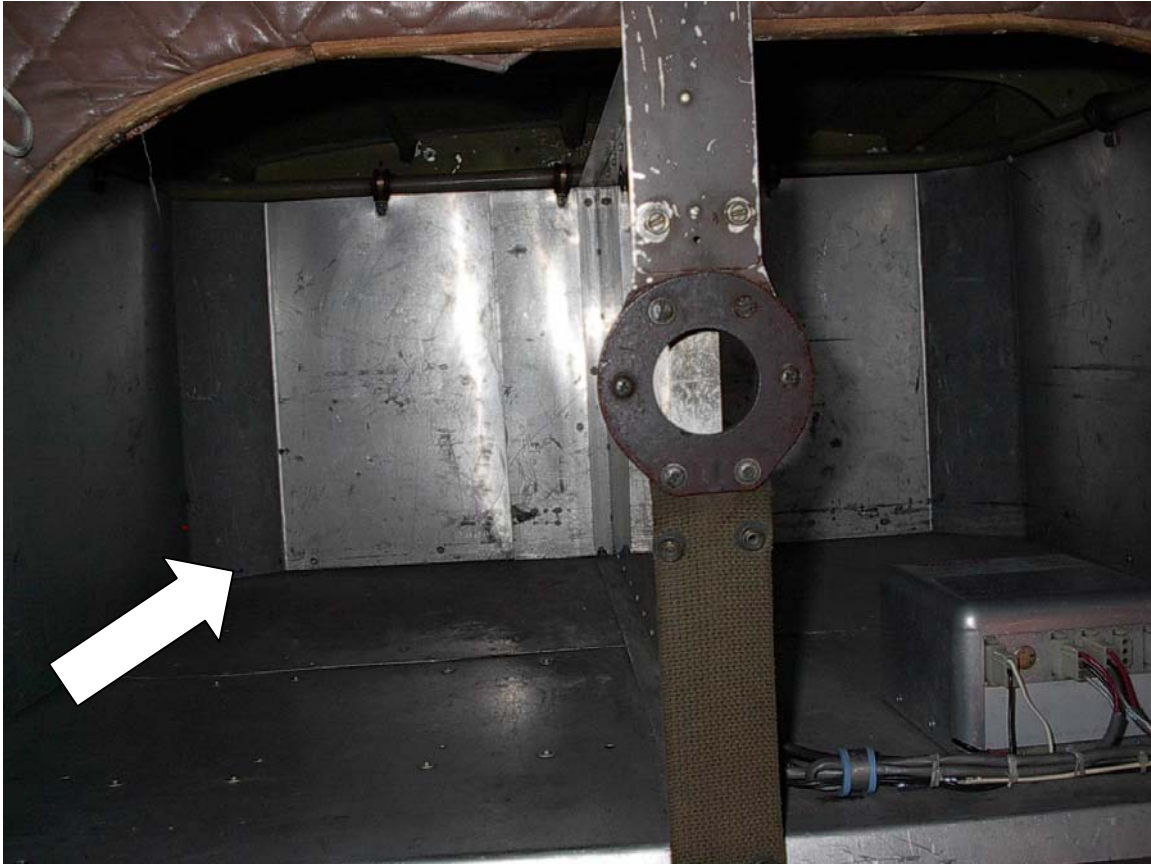
9. No approvals or supporting data found in the reviewed aircraft records for the following installed modifications:
- i. Metal luggage storage compartment

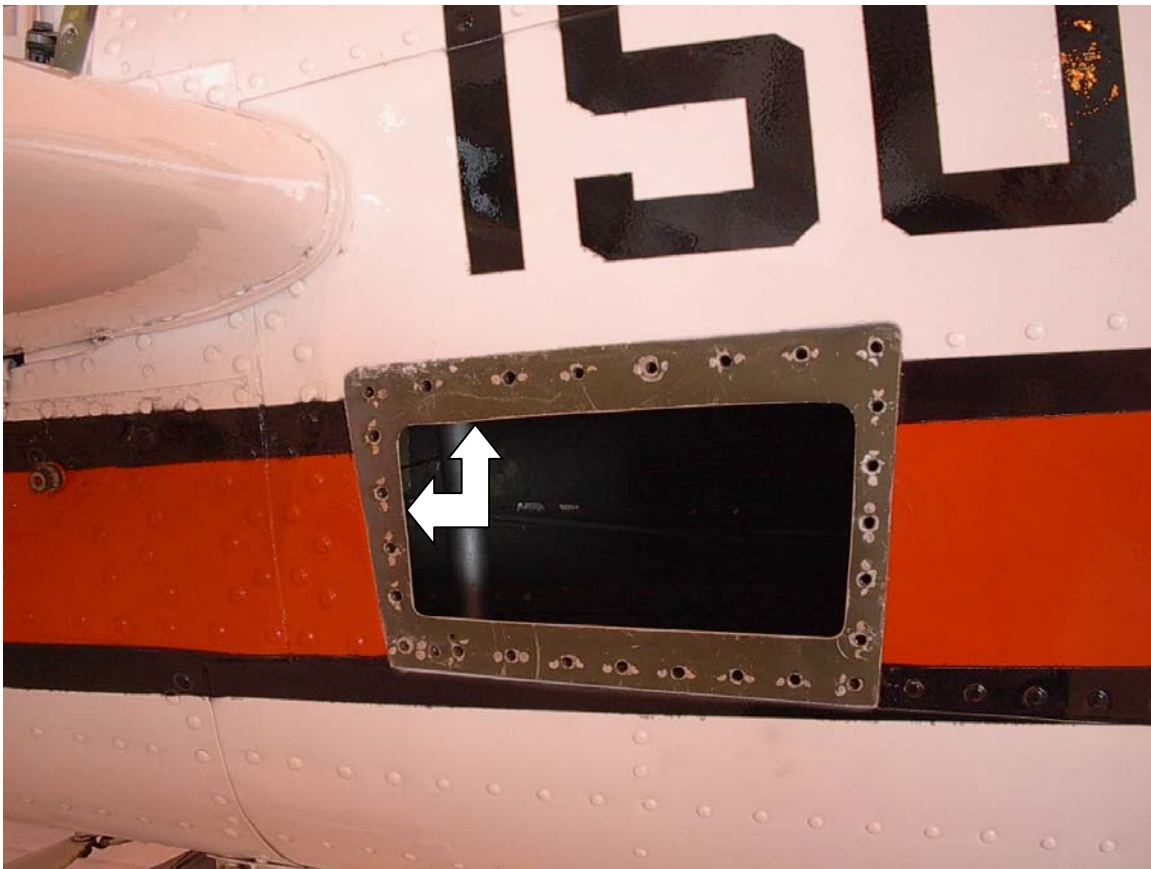
**14. No doubler on the inside of the inspection panel located just forward of STN 228, right side. No data supporting installation in reviewed records.**

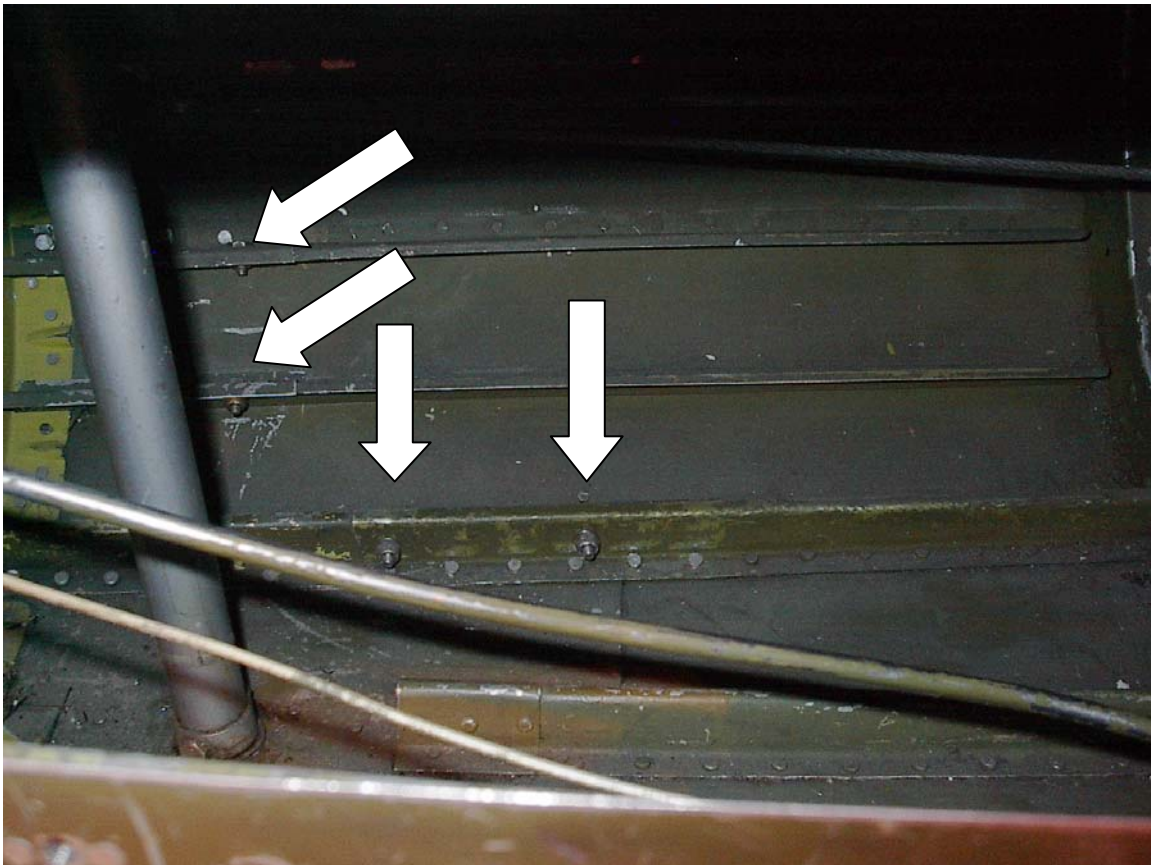
**19. Unapproved repairs (bolts in stringers) in tail section between STN 208 and STN 228. Reference DHC-2 Repair Manual Figure 4-9.**

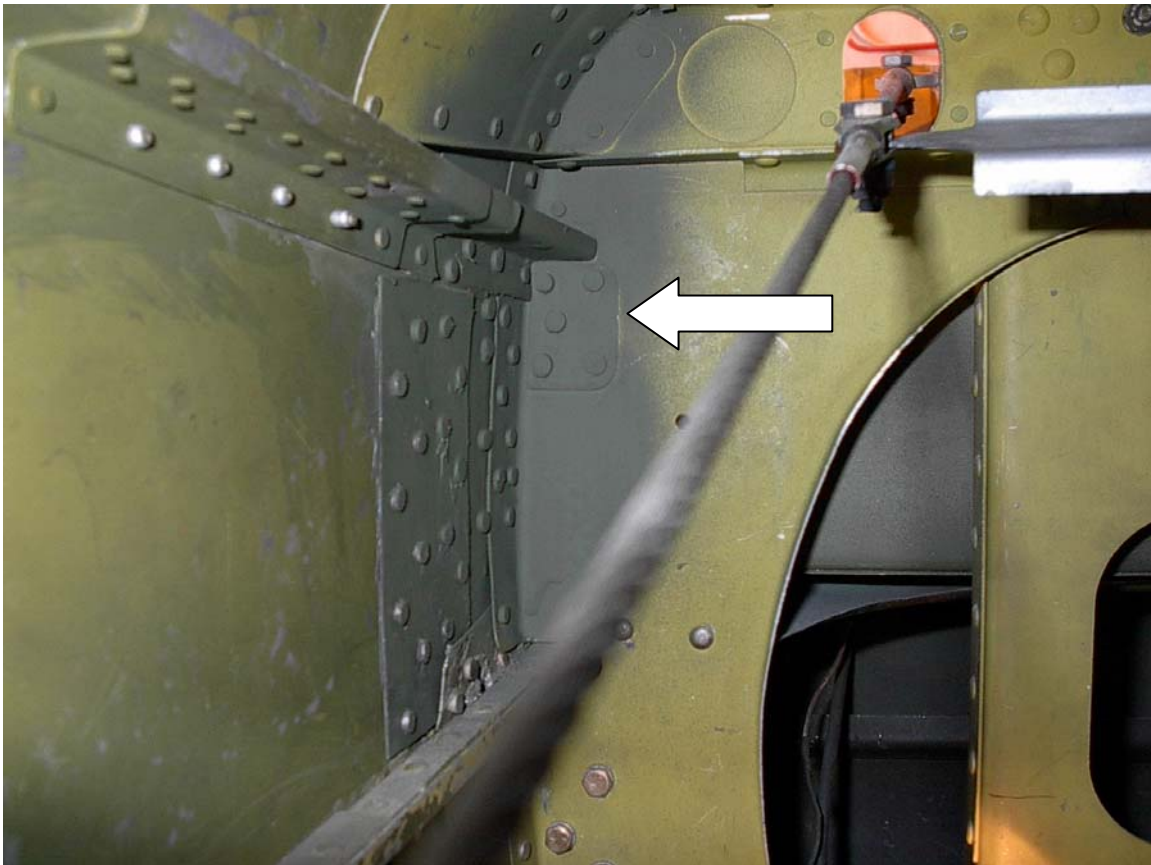
**20. Structural support brackets (P/Ns C2FS5215/16) for tailplane pick-up missing.**

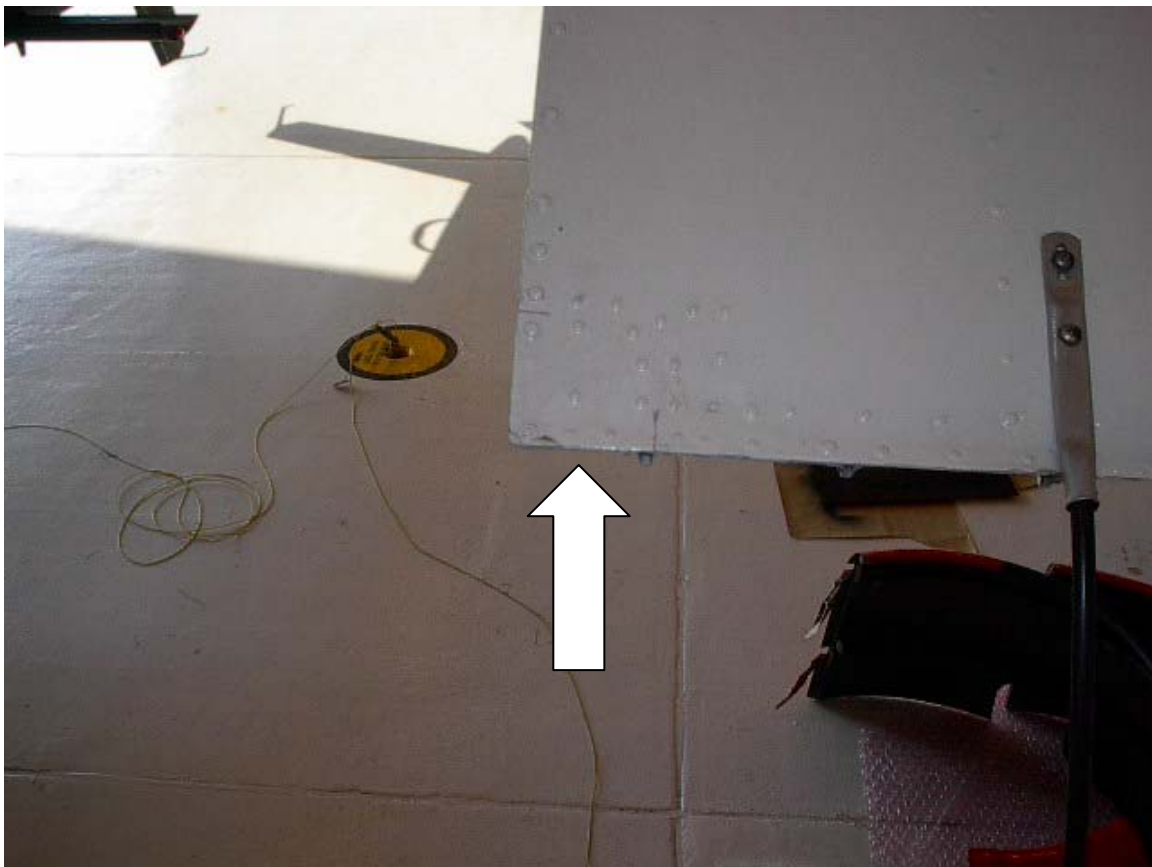
27. Left aileron outboard top skin has unapproved repair, reference DHC-2 Repair Manual, Section 2, paragraph 2.25.

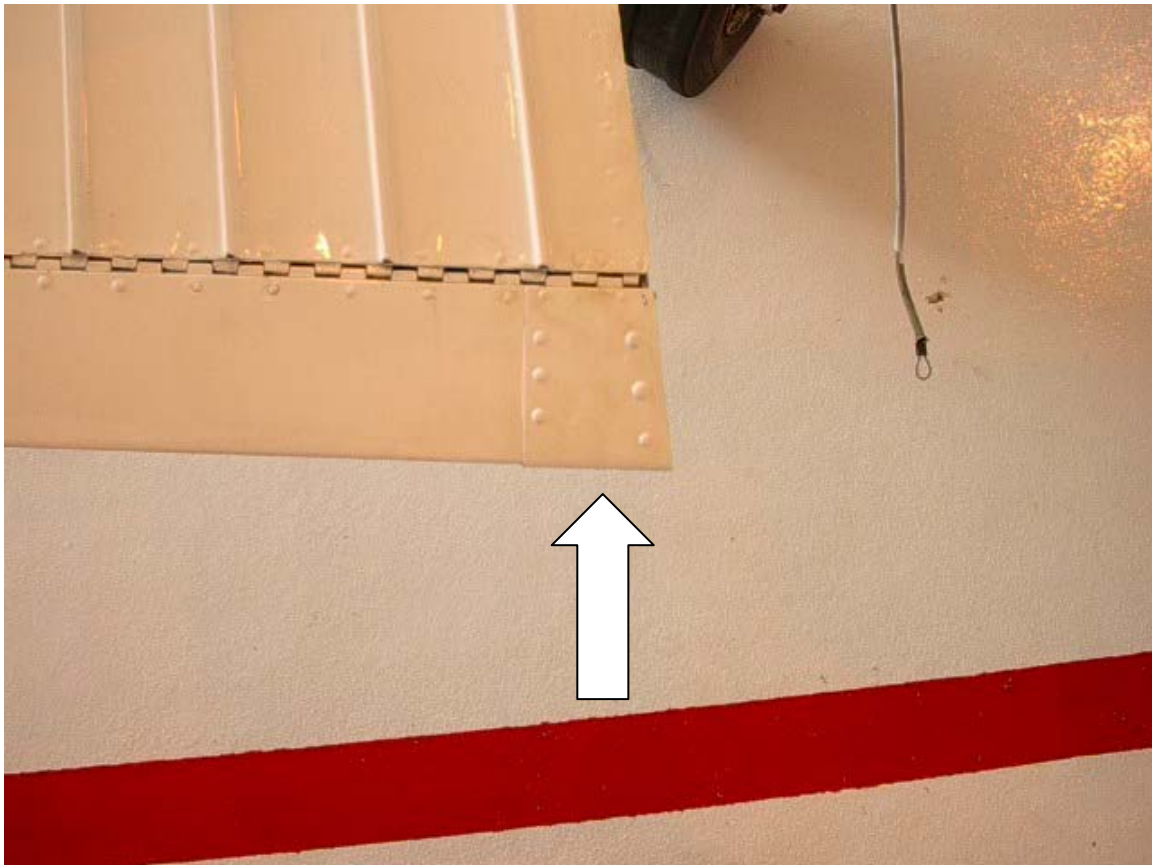
30. Left elevator trim tab has an unapproved repair, reference DHC-2 Repair Manual, Section 2, paragraph 2.25. Repair has resulted in left trim tab being out of rig by 4 degrees.

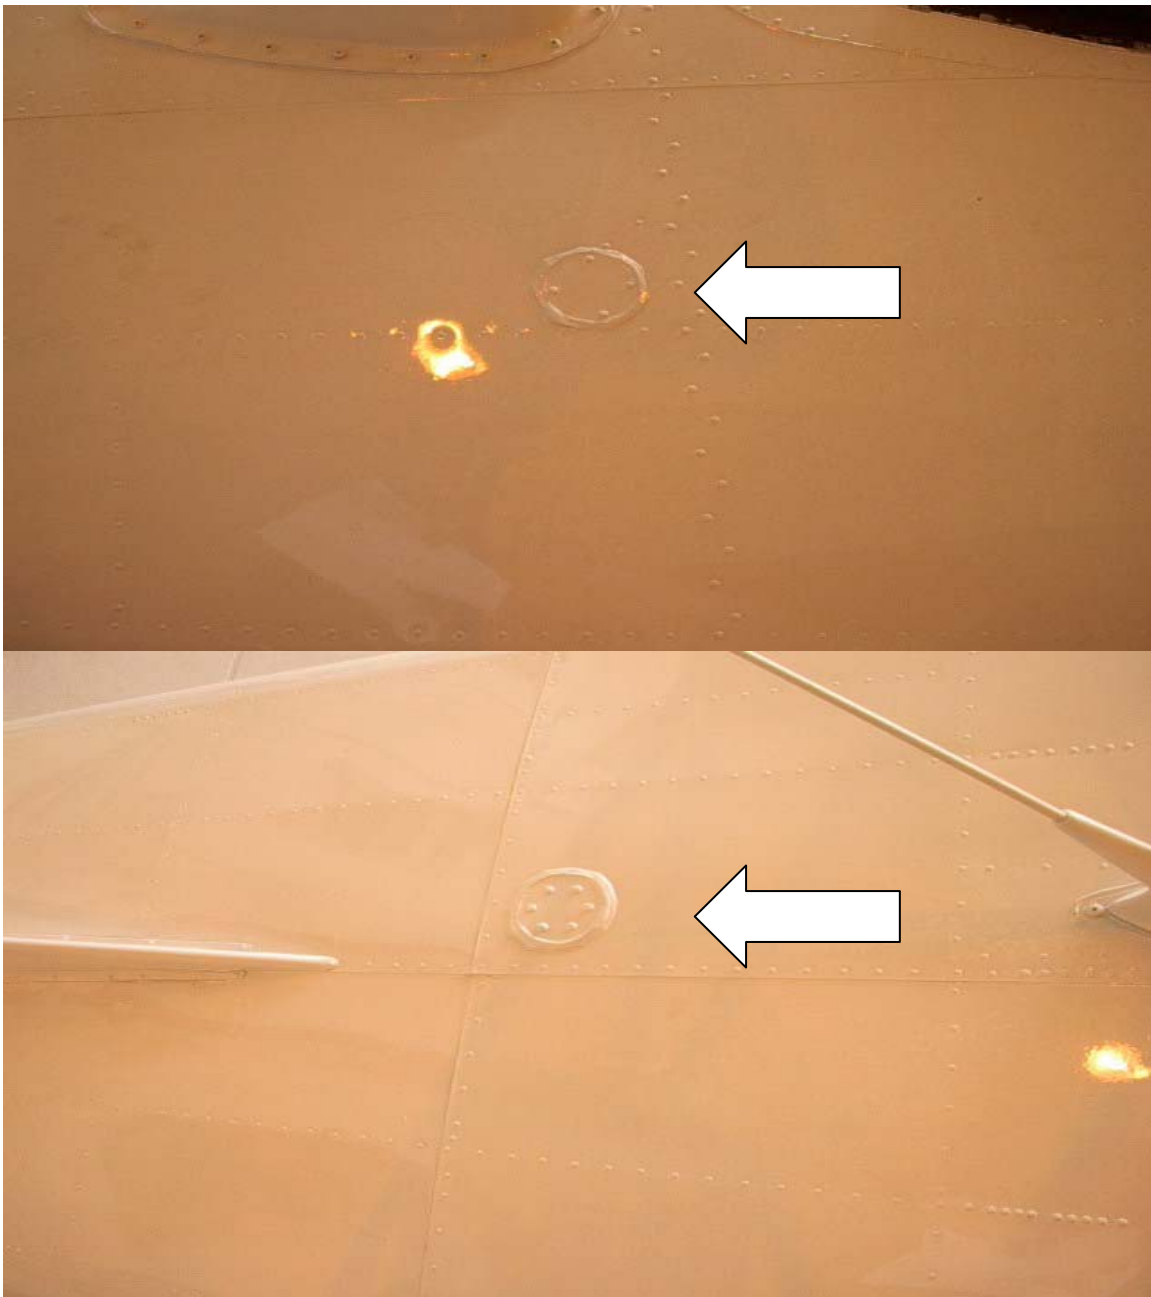
33. Patch repairs on top of fuselage at STNs 76 and 108 not repaired IAW the DHC-2 Repair Manual Appendix 2, Figure B1.

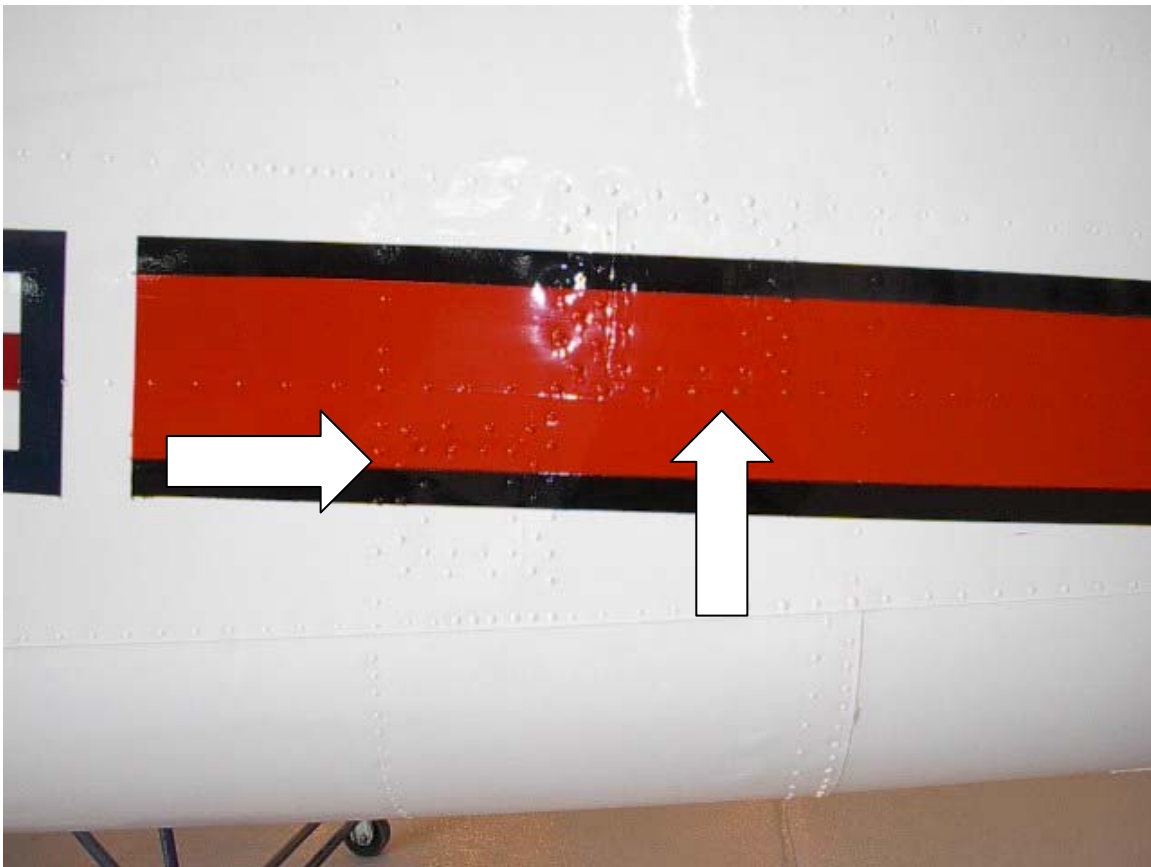
- 35. Elevator and rudder pulleys have heavy control cable grooves at STN 104.
- 36. Two patches on left fuselage skin at STN 165 not installed IAW the DHC-2 Repair Manual Appendix 2, Figure B1.

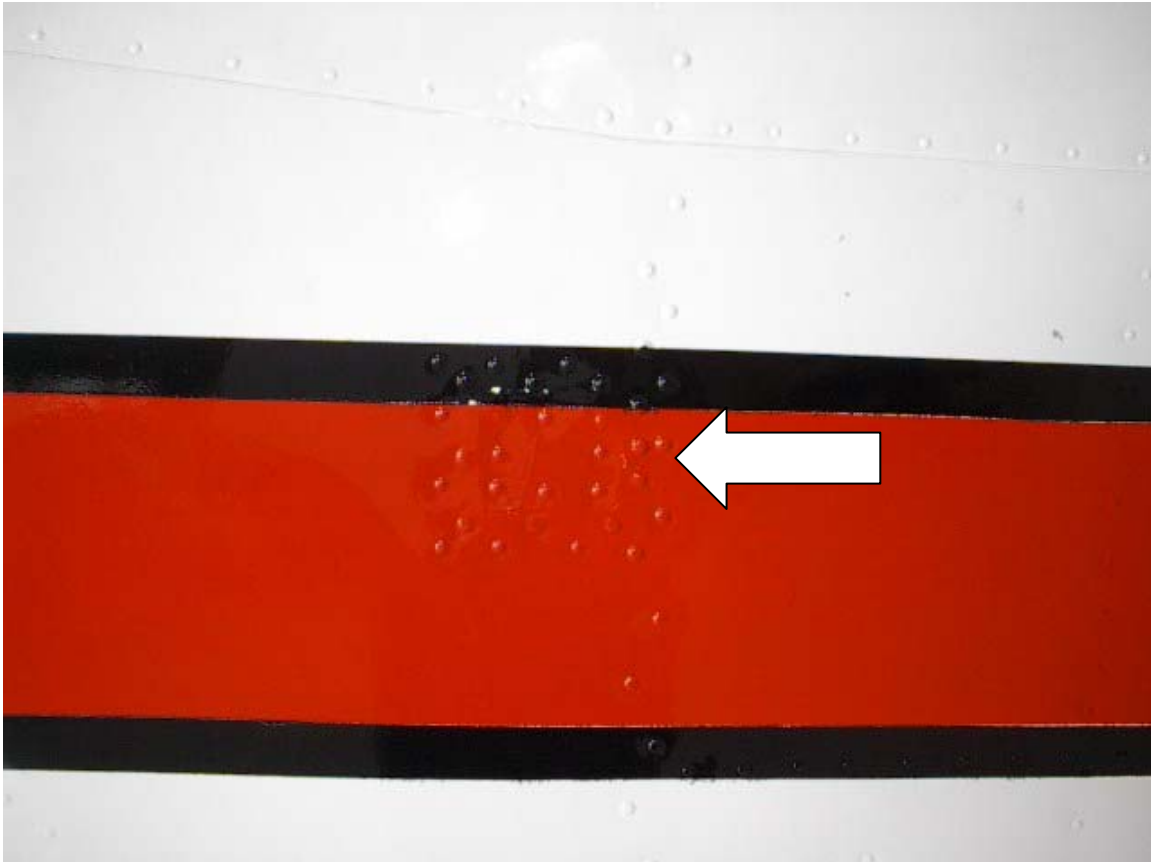
43. Pitot and static lines routed so that drains are not at the lowest points in the systems.
44. Left side skin repair at STN 76 not IAW DHC-2 Repair Manual Appendix 2, Figure B1.

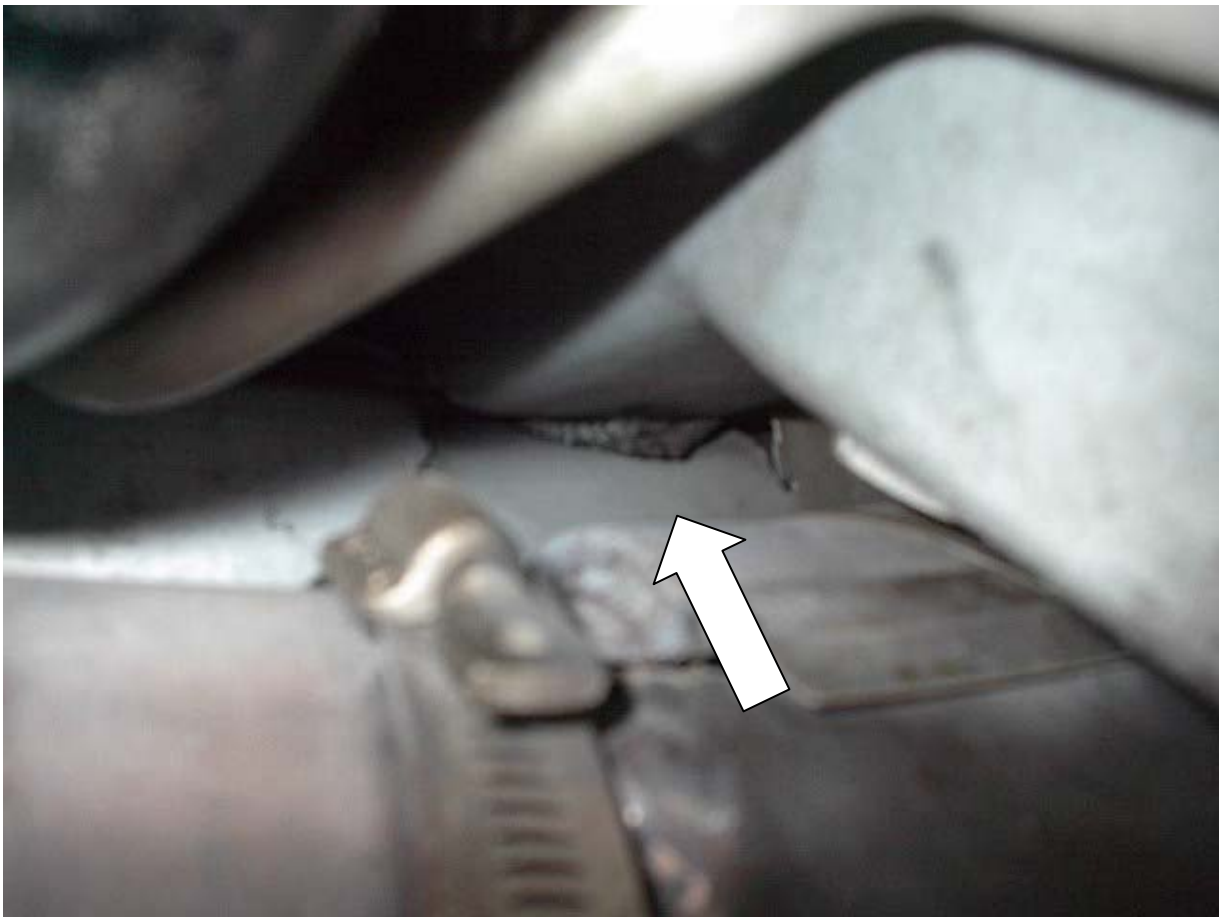
**51. Left aft fuselage side skins cracked in numerous places just forward of STN 228.**

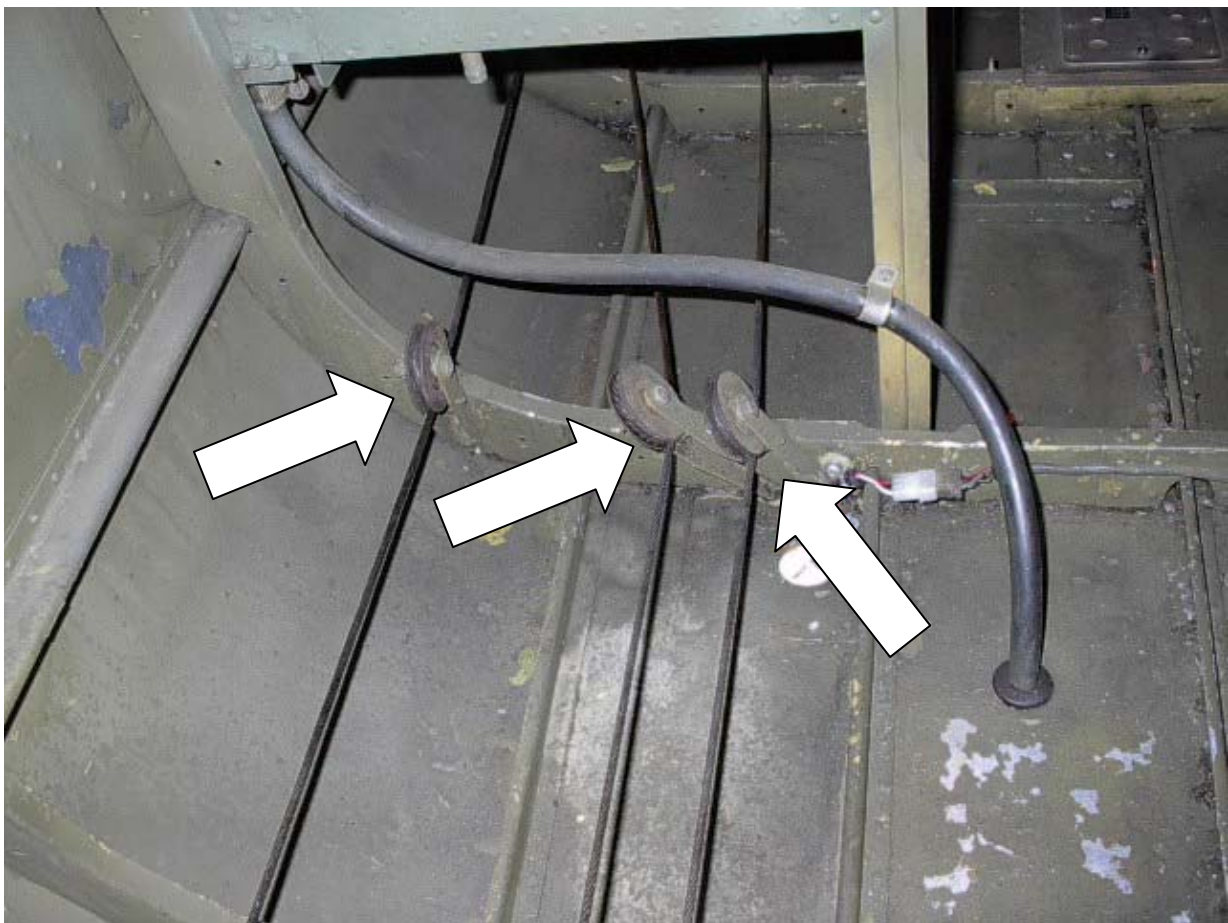
11. Two (2) cracks in center fuselage cabin roof skin support bracket just aft of the flap torque tube.
12. Flap hydraulic pump should be lockwired at left spool valve input lever.
13. Flap pump handle crank linkage worn at aft clevis pin attachments.
- 14. Both aft rudder cables worn and frayed at pulley brackets, STN 104.**
- 15. Aft upper elevator cable worn and frayed at pulley brackets, STN 104.**

- 16. Recommend the aileron control cables in the fuselage should be removed and inspected for wear and fraying.**

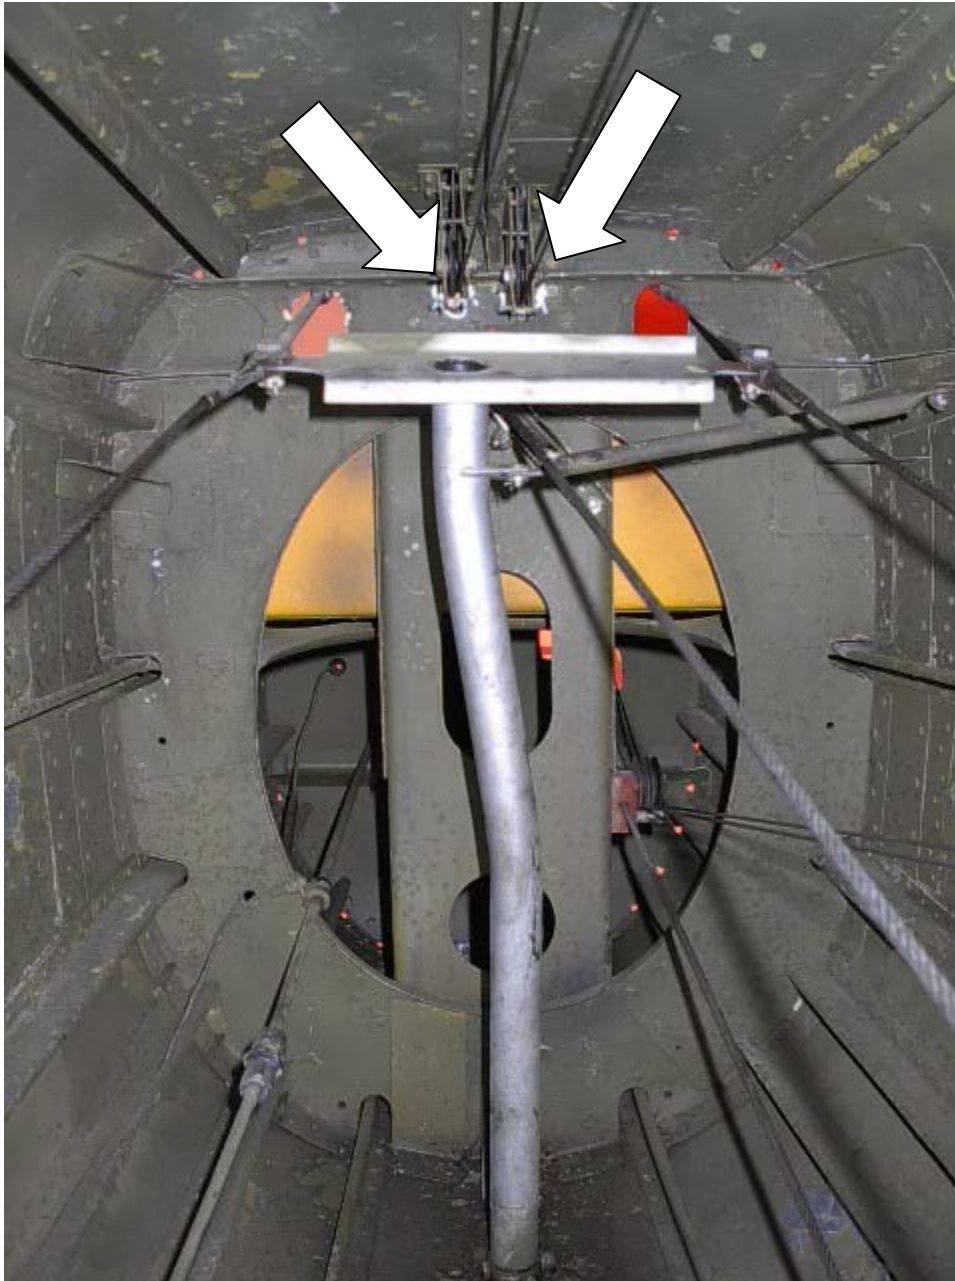
During the initial inspection of the aircraft, it was noted that the glider towbar centerline was to the left of the airplane centerline. Upon removal of the towbar and comparison to the towbar removed from No. 34, both towbars appeared to be identical. During the symmetry check on No. 35, it was noted that the empennage was asymmetrical, with the horizontal stabilizers shifted to the left by 5/8 inch. This indicates the possibility of high side loads imposed on the tail of the airplane, and might account for the cracking noted in the STN 228 bulkhead and aft channel.

**18. Aft fuselage channel, P/N C2FS405A at the top of STN 228 is cracked at rudder horn attach bolts.**

Because of the condition of the bulkhead and aft channel at STN 228, and taking into consideration that use of this airplane includes glider towing, we recommend replacement of the bulkhead and channel prior to further flight. We also recommend a more thorough and detailed inspection should be performed for additional damages once the cracked bulkhead and channel have been removed.

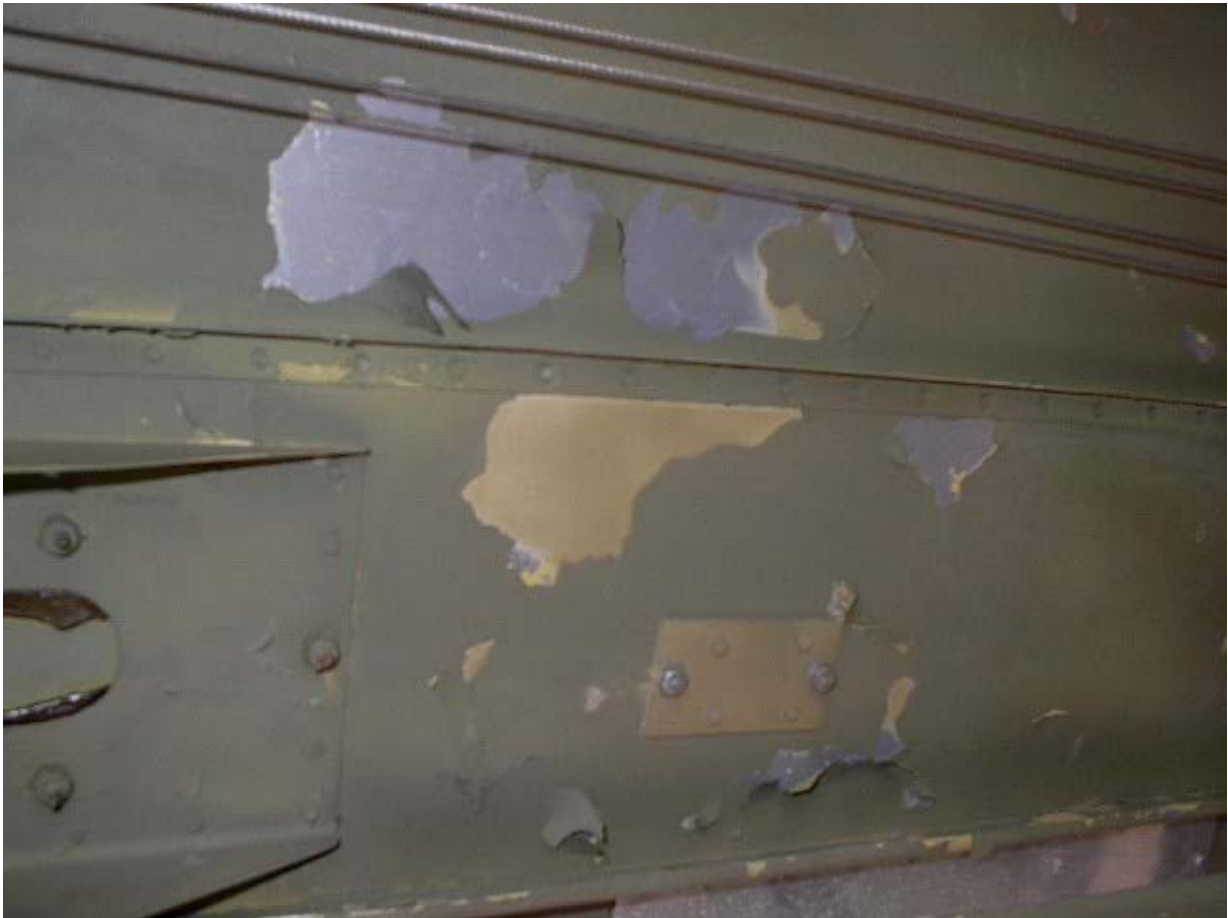
46. Numerous areas of primer peeling from the inside of the fuselage skins, leaving bare metal.

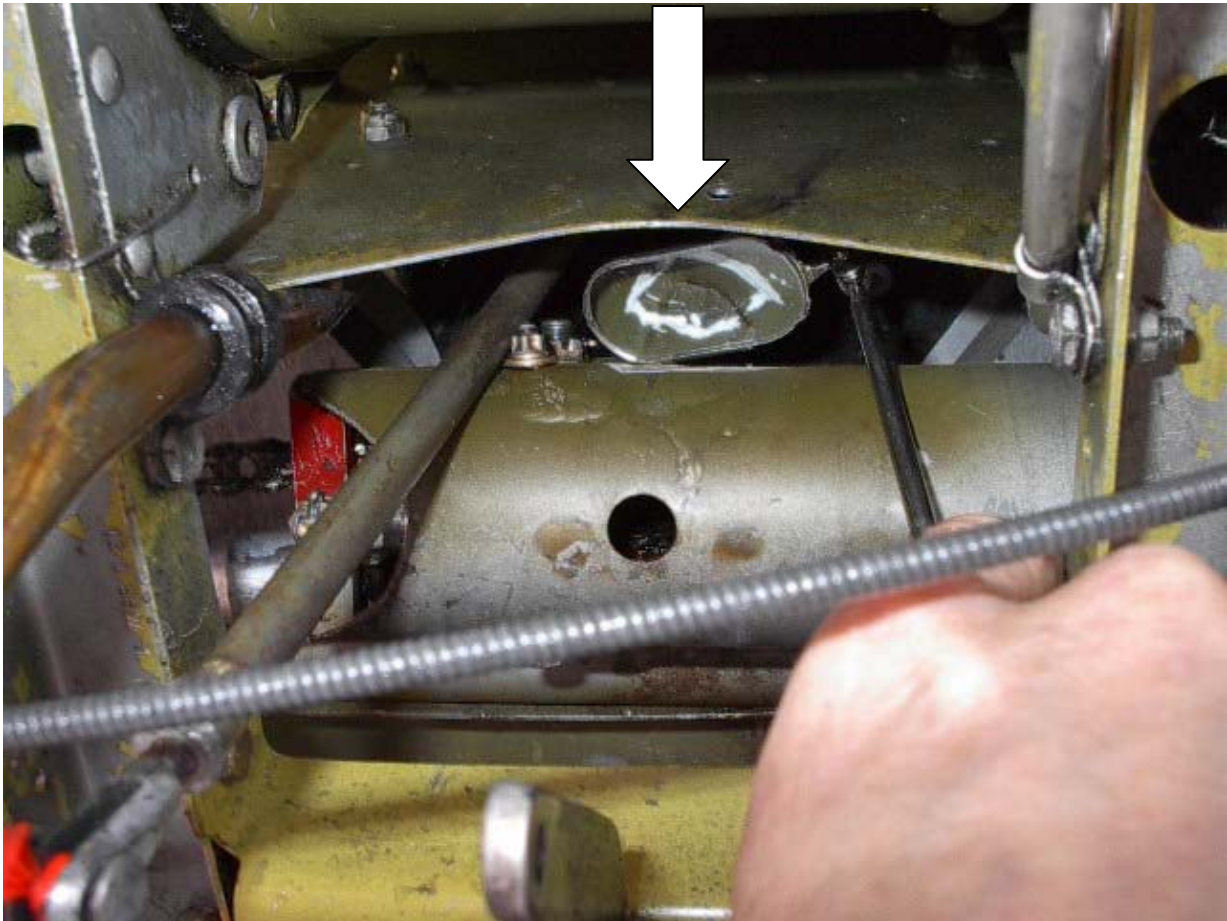
During the inspection required by AD 84-09-06, cracks were found at the base of the control column. The AD requires repairs to be accomplished before further flight.

**47. Control column cracked at bottom end.**
